TWO BLACK

© Alf Wilford, Australia
awilford@clocksmagazine.com

K MANTELS

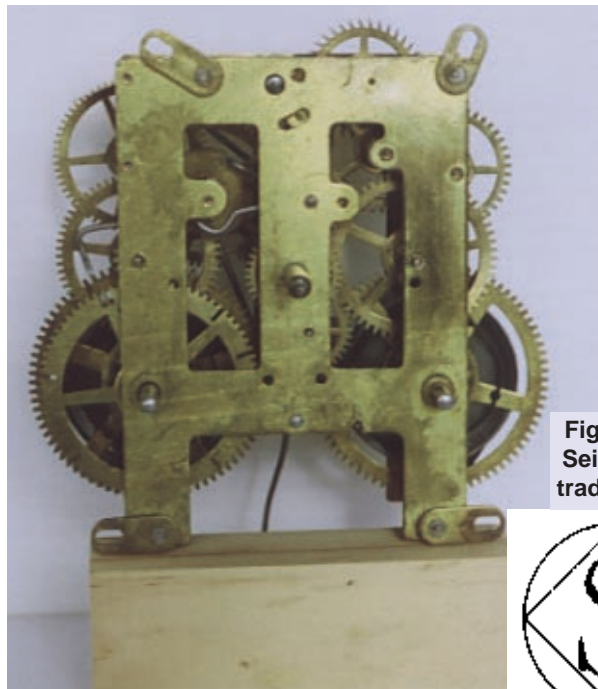
The other repair, however, was not properly done. Someone had tried to close up the wear in the hole supporting the front pivot of the second wheel arbor by punching around the hole. This had resulted in a bearing surface which had spot contact only with the pivot. Daylight could be seen through the hole in several places where the bearing

Figure 2. Front view of Seikosha movement.

surface did not meet the pivot!

After dismantling the movement and inspecting all parts and burnishing the pivots, I used a small round file to enlarge the hole in the front plate for the second wheel pivot, being careful to keep the hole concentric with the outer edge of the oil sink. As a further check on accuracy I also measured the co-ordinates of the corresponding hole in the back plate and compared these

measurements with my progress on the front plate. After broaching out the hole wide enough to accept the tapered portion of a Bergeon reamer appropriate to the bush chosen, and finishing the job with the Bergeon bushing tool, I succeeded in fitting a bush tightly in place. Some of the punch marks are still visible around the bush, but the pivot is now properly supported in a bearing that will last and work effectively. After

cleaning all parts, the movement was assembled and oiled. **Figures 2 and 3** show the overhauled movement.

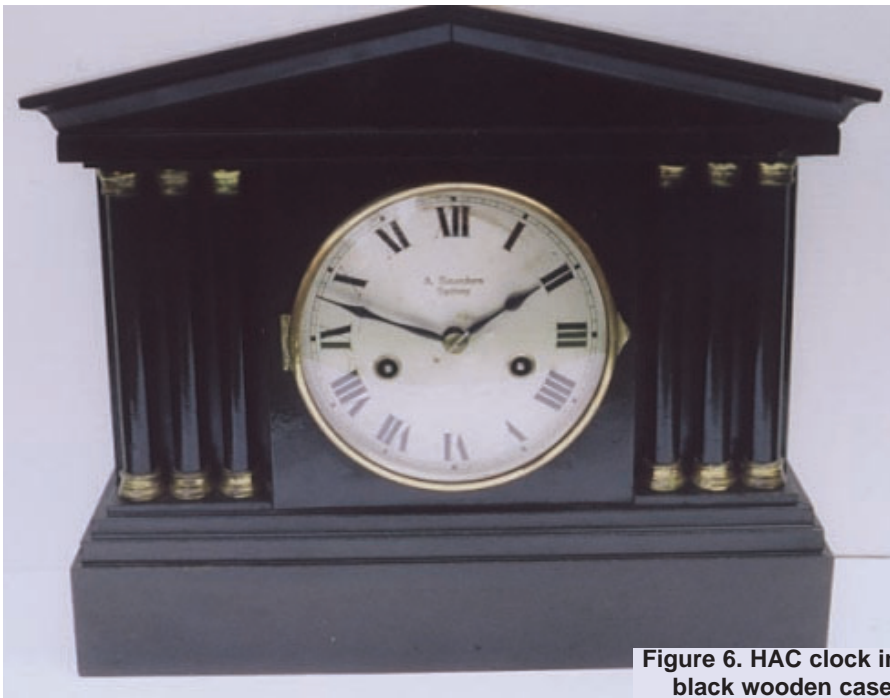
Figure 6. HAC clock in black wooden case.

When the lady gave this clock to me it was in a down-at-heel state. The glass was broken and the bezel hinge had broken away from where it had been soldered. The bezel was removed from the case for re-soldering, and the old soldered surfaces scraped clean. After positioning the hinge carefully, some flux was dabbed on to the surfaces to be soldered. Care was taken not to allow flux to go anywhere else. A large electric soldering iron was used to apply plenty of heat to the parts of the hinge to be soldered and solder was applied sparingly to those parts. The bezel was washed thoroughly when soldering had been completed. It is important to take care when soldering a bezel hinge as it is all too easy to solder one solid if too much flux and solder is applied! The broken glass was glued together and measured. A new convex glass of the correct size was purchased and fitted and the bezel was put back on the clock case.
