# CALENDAR WHEELS

Why are so many missing and what can we do about it?

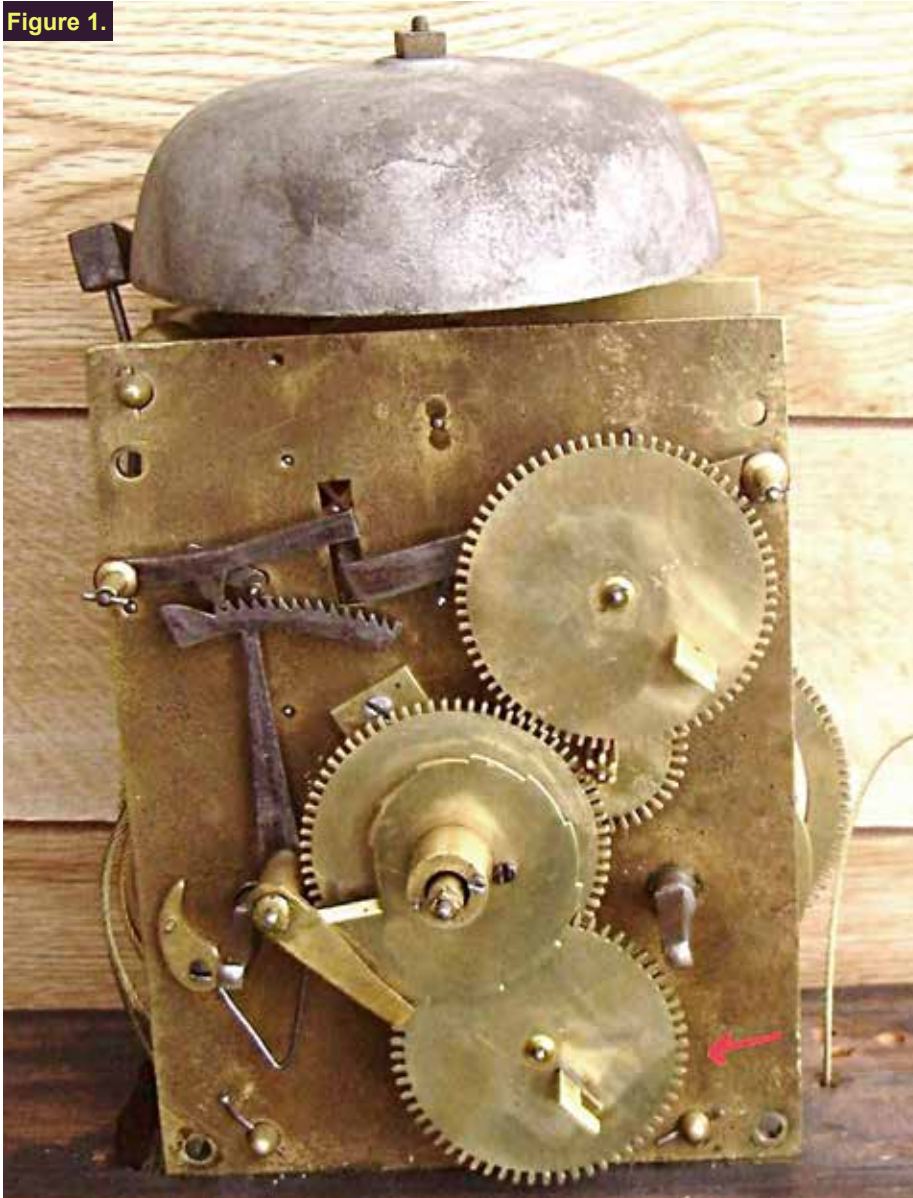
Figure 1.

I wonder if restorers who handle brass-dial longcase clock movements are as amazed as I am by how many are missing their calendar-drive 24-hour wheels. For those who don't know, I refer to the wheel that takes the drive from the hour pipe and tips the calendar ring round by means of a pin or flag on its outer surface. A movement with the wheel and its flag intact is shown in **figure 1** and the ring that it turns is shown in **figure 2**.

The wheel is driven by a gear wheel on the hour pipe that on countwheel strike is open to view, **figure 4**, and on rack strike is behind the snail, **figure 1**. As the hour pipe rotates once every 12 hours, to get a 24-hour rotation we need a two-to-one step down. Then it is a simple matter to measure from the mounting stud to half the depth of the teeth on the hour pipe (it's called the addendum), double it and we have the diameter of the new wheel we need. These wheels are readily available from specialists such as Michael Debenham and Peter Holtby who advertise in this magazine. These specialists will also supply the collet to mount it and the pivoting stud if this is missing.

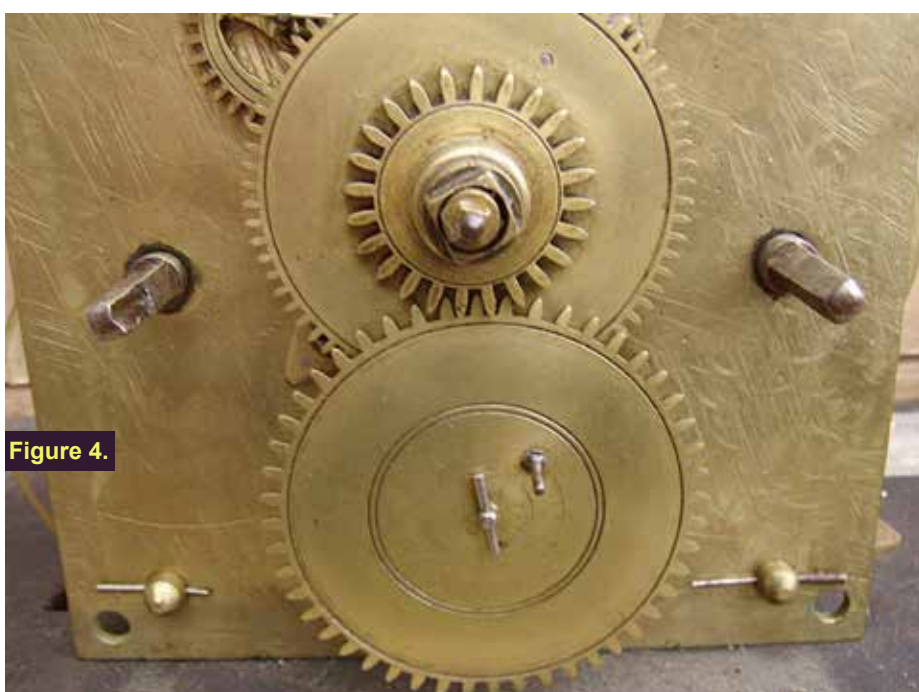
Figure 7.

When the movement came to me, the calendar ring behind the dial was an obvious and incorrect replacement, **figure 7**. It was too narrow and did not cover the aperture in the dial plate. The god of clockmakers smiled on me and I was fortunate enough to find a better replacement in the spares box, **figure 8**. The old one is on the left, the new one on the right. However, my good luck finished there and when put through its paces, the numbers on the replacement ring did not come in the centre of the aperture and the only solution was to move the 24-hour wheel. Examination of the movement front plate revealed that a previous restorer was aware of this but his attempts to correct the problem using the narrow calendar ring had proved unsuccessful, as it has to be said, they were bound to. The front plate, in addition to several holes, had also been plugged in two places, **figure 9**, so he could not be condemned for lack of effort.

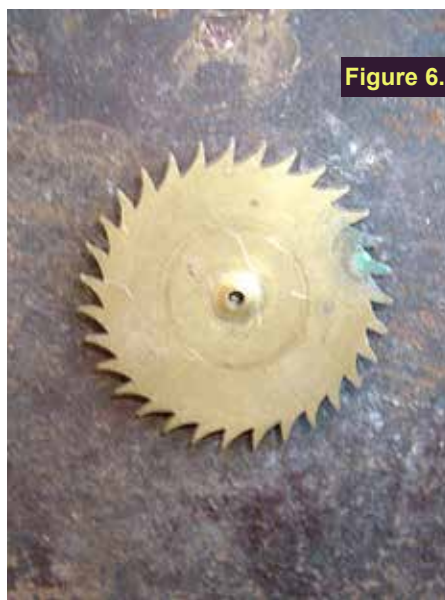
Figure 5.

also restricts the end float and does away with the necessity for a fiddly pin hole in the end of the mounting stud, **figure 5**.

One sometimes sees a pin fitted to operate the ring and while this can be perfectly adequate I like to use a flag myself. They can be slotted into the wheel and riveted over to provide a more secure fixing. In fact, in some cases, a flag is the only way because with rack striking, a step has to be cut in the flag to allow clearance for the rack tail, **figure 1**. To provide maximum clearance for the rack tail, I have in the past fitted the operating flag in the end of the wheel collet so that it almost butts up against the dial plate and in addition to the increased clearance

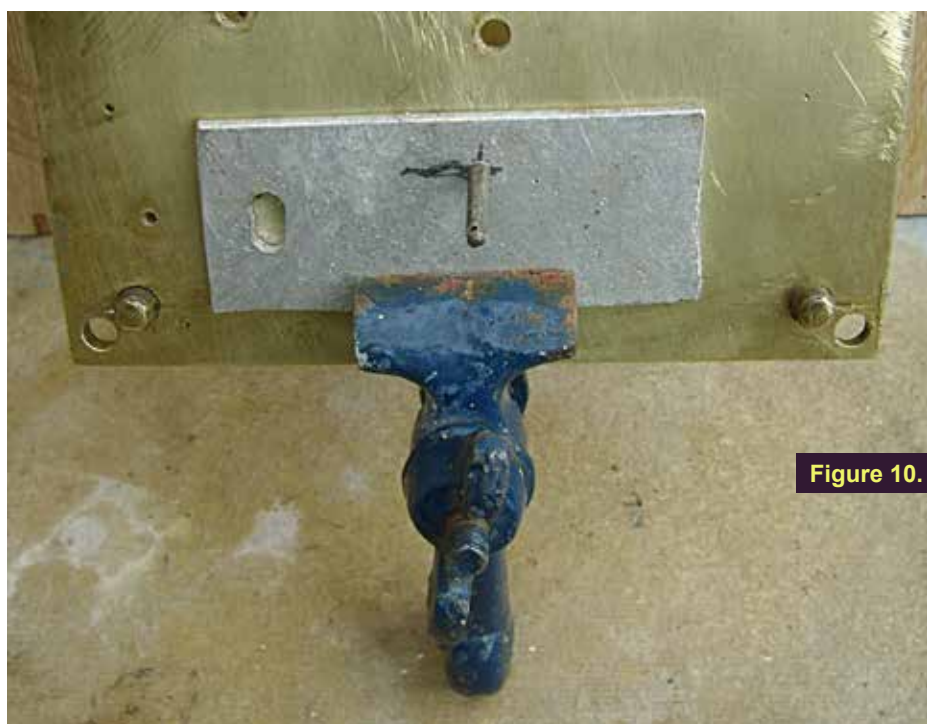
Figure 10.

Then a piece of plate was tapped and fitted with a pivot stud and clamped to the front plate, **figure 10**, and the wheel dropped on. The dial was offered on to the movement with the calendar ring in position and the plate moved until the numbers were central in the aperture when the wheel was turned. The position of the stud was noted and the front plate drilled and tapped to take it.

I hope readers will be amused to learn that I got it wrong the first time and the stud was 1mm too high and the wheel would not mesh. Luckily, the hole came dead in the centre of one of the plugged holes and I was able to knock it out, replugin and tap a fresh hole. This repair proved successful but it was time-consuming and I would ask potential customers to bear this in mind when they are quoted what they feel are exorbitant prices by professional restorers.
