I like the idea of the cuckoo clock. I like the whole Black Forest story—the myths and legends that have grown up around it seem splendid to me. But the modern touristy versions of the cuckoo clock can be a bit trying at times. I often tell owners of modern eight-hour cuckoo clocks not to expect too much of them as clocks, but to enjoy them for the pleasure that they obviously give doing their thing hanging on the wall.

Figure 1 shows an architectural style of cuckoo clock, c1880 and made by GHS (Gordian Hettich Söhne) with a substantial single fusee, spring-driven brass-plate movement and cuckoo-and-gong striking. The large case was of oak in a natural finish with very nice carving. Most cuckoo clocks seen today are hanging weight-driven wall clocks

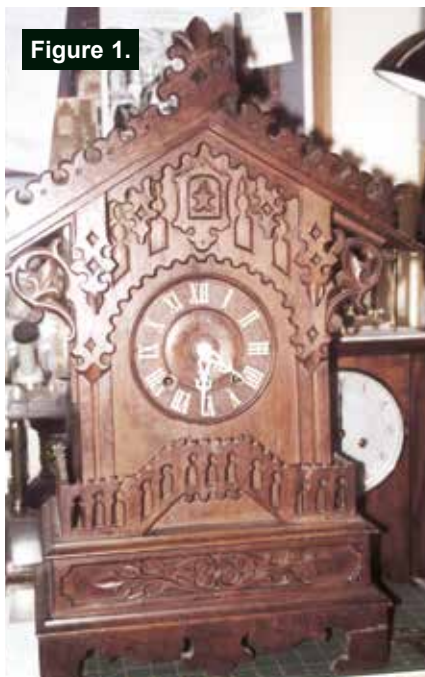
Figure 1.

clock was not going or striking, and a quick appraisal showed that it had acquired a French pendulum, had plastic hands instead of bone ones, and that there were several cracks around the case and especially a large crack right through the dial and case. Both bellows were unserviceable, the back door gong was missing, all the linkages were non-original and six turned pediments were also missing.

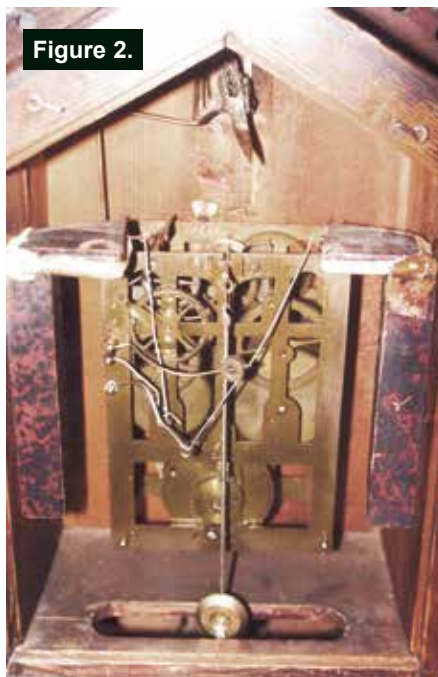
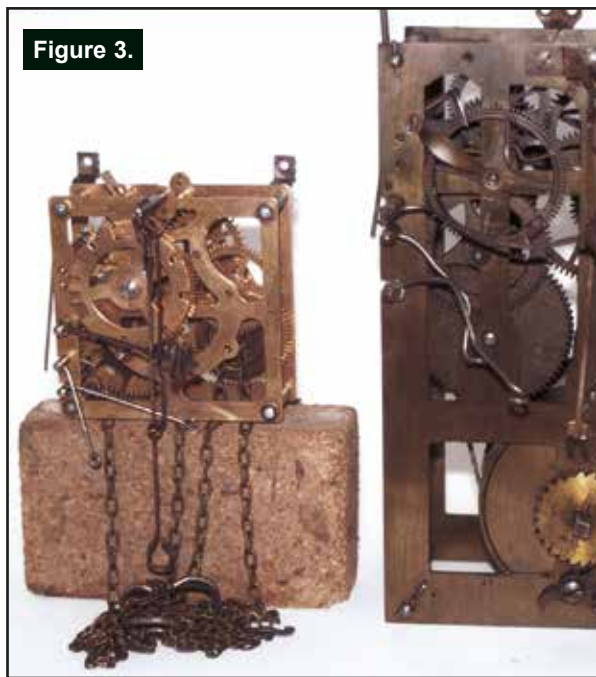
Figure 2.

stamped movements around 1900. However, the early history of the invention of the cuckoo clock and its makers is shrouded in contradiction and myth. A search through the past indexes of *CLOCKS* magazine will find several articles and references to the Black Forest, cuckoo clocks, their repair and their history. For example, the May 2000 issue has an article by Simon Drachman which discusses and compares a clock by Beha and one by Gordian Hettich & Söhne, the latter being the maker of the clock which is the subject of this article. So I will focus my article on a description of the restoration of the clock, and some of its parts, which may prove useful to the reader. After removing the bellows pipes and connecting wires from the case, the movement was also removed and appeared in good condition with nothing missing or broken, **figures 2 and 3.**

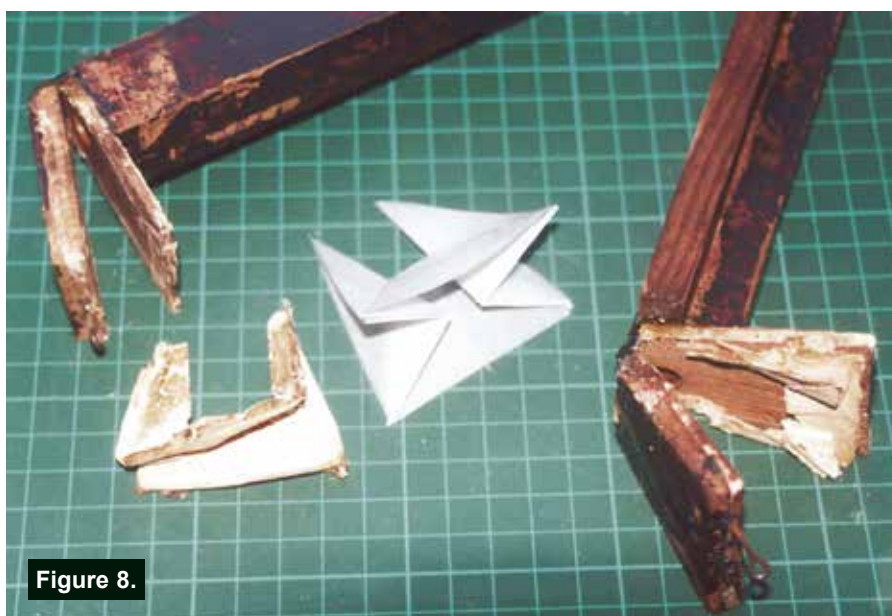
Figure 8.

The bellows, **figure 8**, which I think were original, had been repaired, patch-upon-patch, and were rotten and torn. The activating wires were definitely non-original and were just twisted into place. Dealing with the bellows first, the original remains were very carefully removed from the pipes so that they

could be used as some sort of a pattern. Don't forget, when removing the pipes, to mark them 'left' and 'right' because they sound different notes.

Replacements for bellows, or complete pipes, are cheaply available for modern cuckoo clocks but antique clocks have much larger pipes and the bellows are not rectangular but are more fan shaped. I use the special paper sort of fabric that is available from suppliers when making up modern bellows but for this clock I found some incredibly thin leather. It was a discarded exotic piece of ladies' wear. I love the thought of it going 'cuckoo, cuckoo' in its recycled role!

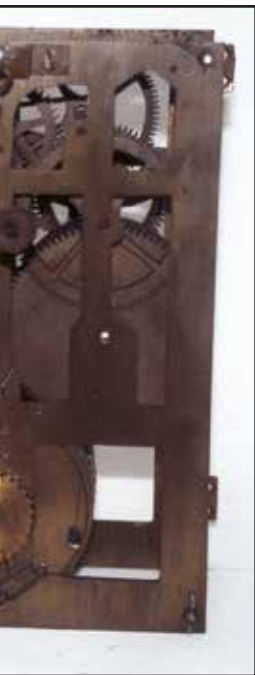
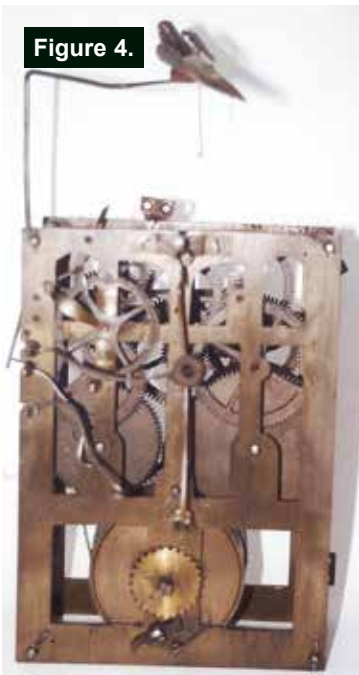
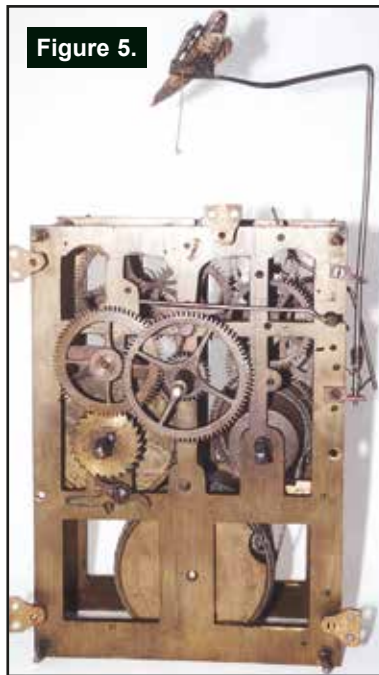
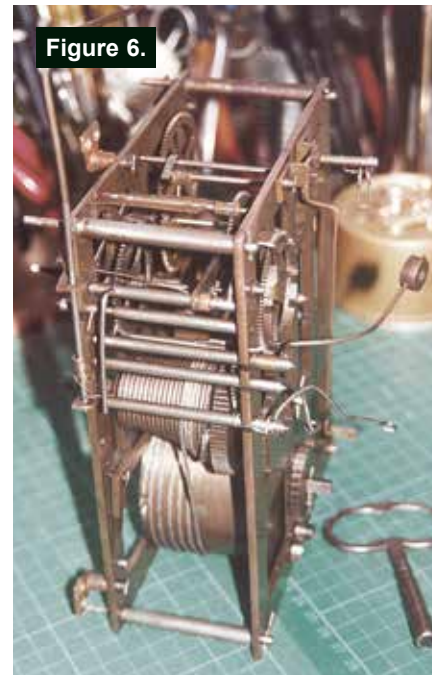
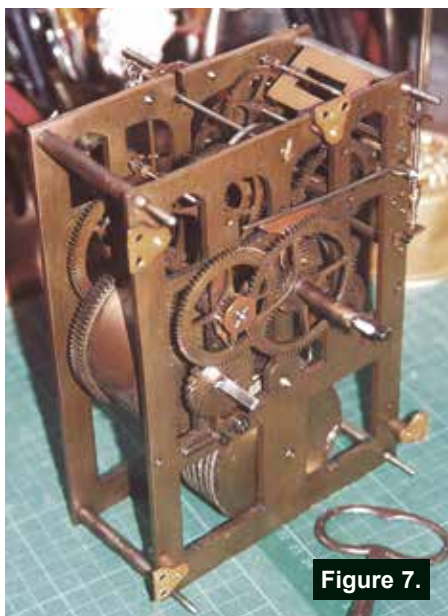
Figure 7.

It was heavy and substantial, 7.5in by 5in and 2in between the plates, **figures 4, 5, 6 and 7**. It was serviced in the usual manner, described many times in *CLOCKS*. It was stripped into its component parts, washed in a cleaning solution, rinsed and dried.

The brass parts were scrubbed with Brasso and polished. The leaves and wheel teeth were brushed, arbors lightly polished with fine emery paper, pivots and escapement pallets burnished and bearing holes pegged out. The fusee cable was in good condition and was re-used. After oiling, the movement was set up for testing and, thankfully, no surprises were found. A plain bob of the sort seen in illustrations of contemporary examples was made up and substituted for the French Brocot type of bob.

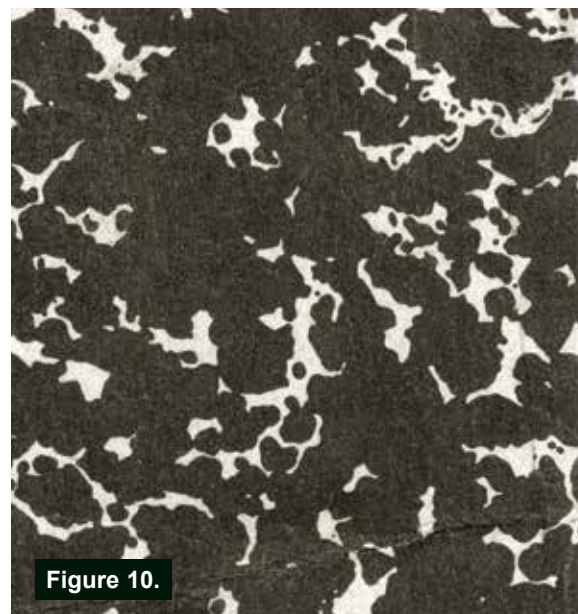
Figure 10.

Most pipes are papered over with a mottled paper in various colours. I don't know if it was intentional, but the *MART JOURNAL*, put out with the *NAWCC BULLETIN*, used to have a cover with this

mottled pattern, **figure 10**. I photocopied this in a variety of colours and use this to re-paper any pipes that need it.

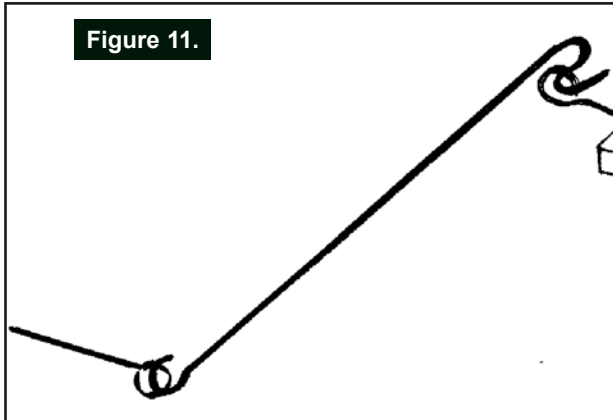
Figure 11.

The activating wires were made up to the approximate lengths of the found wires but, as you would expect, there was quite a bit of trial and error when fitting them later.

The wires look deceptively simple but don't be tempted to 'improve' on them by making closed links and suchlike because the Black Forest craftsmen have spent years refining the 'hook' and 'crook' shape. Soft wire is not suitable and you will need to find a springy but flexible wire, **figure 11**.

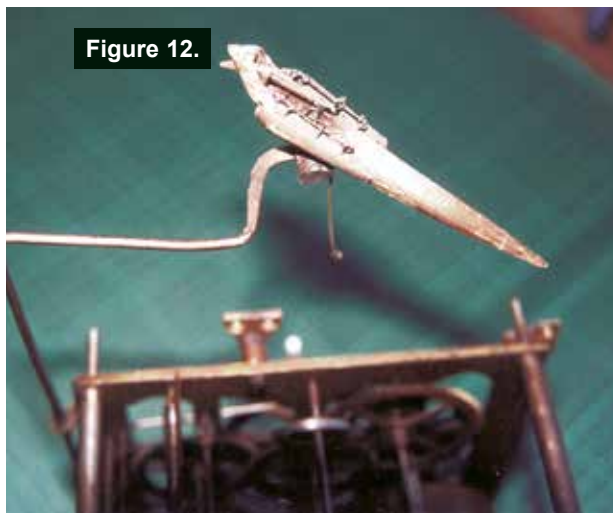
Figure 12.

The cuckoo, **figure 12**, had also suffered much at the hands of time (sorry) and was given delicate surgery to restore the beak movement, replace some of the wires and touch-up the paint. The antique cuckoos were larger and more complicated than the modern version. Ortenburger shows a variety of antique cuckoos on pp88-90 of his book, with advice on how you can date them by the type.

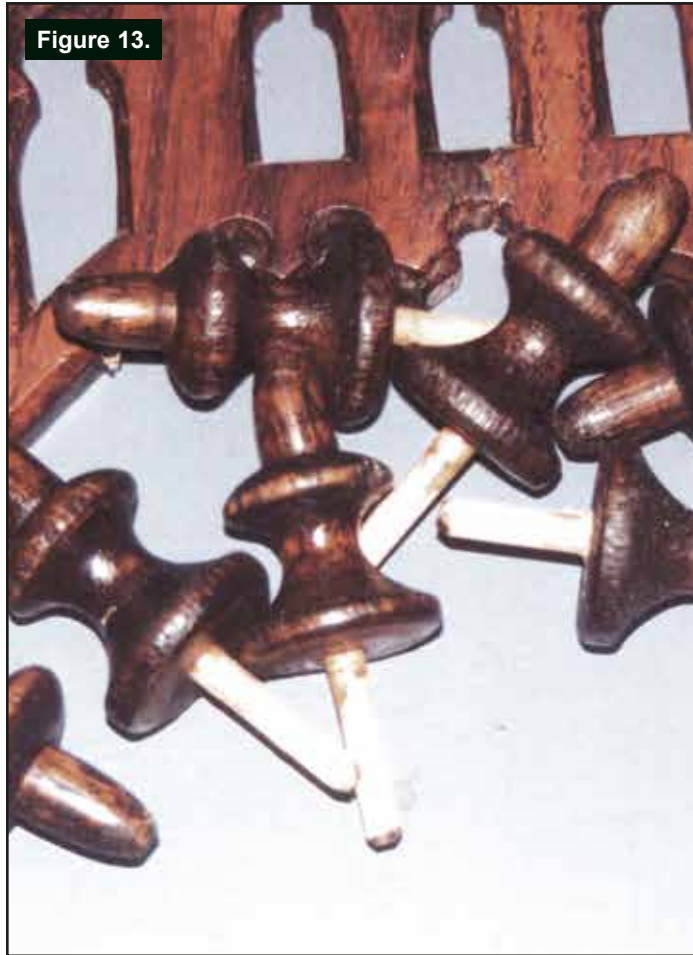
Figure 13.

Meanwhile, the oak case was also receiving attention. Referring to the illustration in Kochmann, it had lost several finials. They were not very complex, in fact, they were of rather uninspiring (sorry again) shape and were easily turned up from a length of dowel and stained to match, **figure 13**.

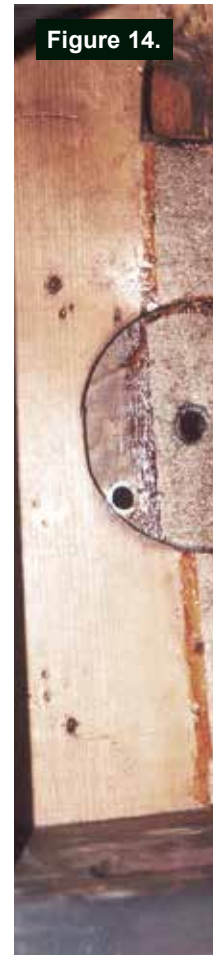
Figure 14.

A couple of spares were also made for the owner of the clock. The front of the case had split vertically right through and included the turned wooden dial. The split had been puttied-up in a rough and visible manner. Several of the carved and decorative parts of the case had, likewise, been broken and poorly repaired, giving a generally scruffy appearance to the case.

I carefully cleaned out the split and filled it with a mixture of PVA glue and oak sawdust. I have several small jars of sawdust of different woods and hues, and find they work well as an alternative to commercial wood filler. If you are going to add stain it works well to add it at the same time. A length of bandage-like tape, used in bookbinding, was glued inside the case to give strength and discourage further opening of the split, **figure 14**.

The fretted parts were removed where necessary and re-fitted and similarly filled with the sawdust/glue filler so that the repairs were less noticeable.

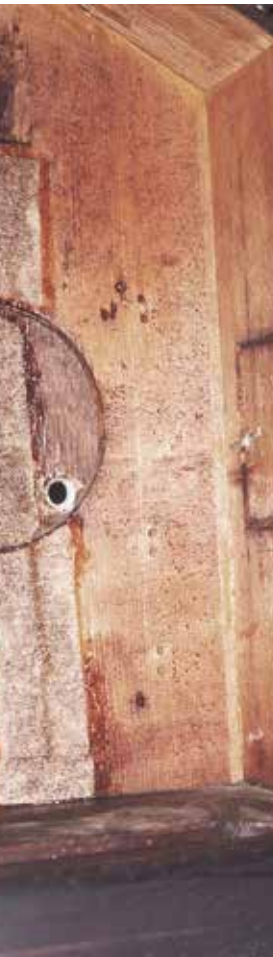
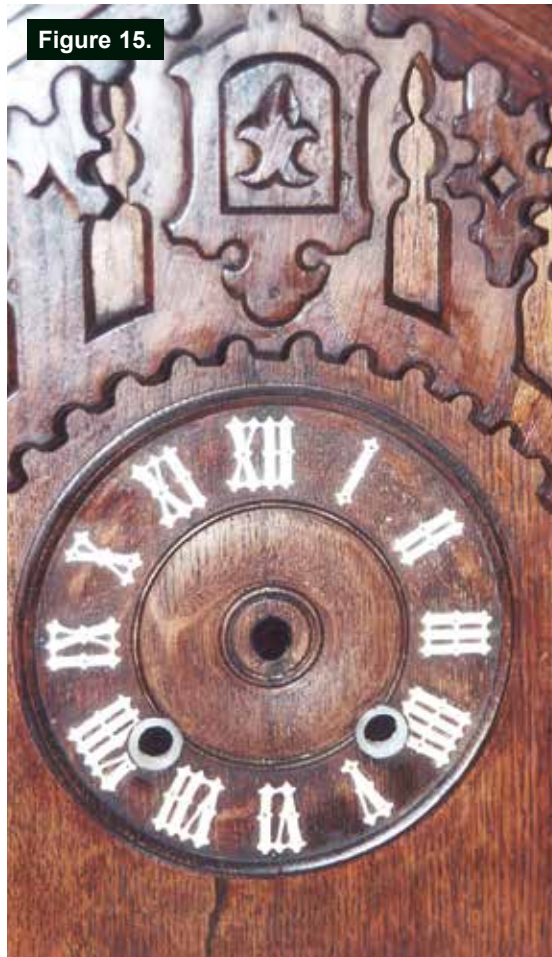
Figure 15.

The turned oak dial had the original bone numerals but many were loose and there were a few broken corners. The re-pinning and cleaning was a slow and careful operation but the finished result was well worth the effort, **figure 15**. The hands, however, were modern plastic replacements. I dallied with thoughts of attempting to make replacements out of bone, but the reality

of the customer paying for my making them soon had me making the best of it by filing and shaping the flat plastic hands into something more sympathetic to the originals.

A quick wiping on and off of stain, to add some dimension to the modelling, gave a quite pleasing result and was a big improvement. The winding hole grommets still had a few bits clinging to the holes and there was enough to work out the original size and shape, so I turned up new ones from a bone-coloured nylon material that had been used to make up vintage car suspension bushes. The missing coiled gong was replaced with a new, large-size, modern replacement and screwed, as is usual, to the removable backboard.
