TWO BLACK

© Alf Wilford, Australia
awilford@clocksmagazine.com

K MANTELS

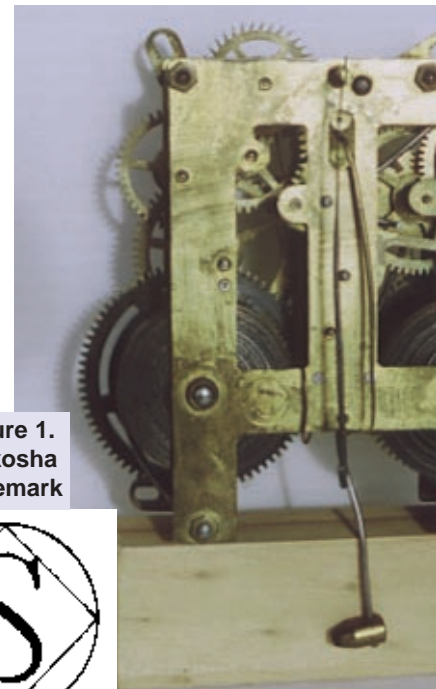
When I saw it for the first time I thought that it could be an American cast iron black mantel clock, possibly an Ansonia or a Waterbury, but when I saw the trademark, **figure 1**, on the dial, the clock was identified as a Seikosha, made in Tokyo, Japan. In the July 2006 issue of *CLOCKS* there is an article on p17 by Peter Gosnell entitled 'Precision Workshop', which is an interesting description of another of this firm's products and a summary of the firm's history.

Figure 1. Seikosha trademark

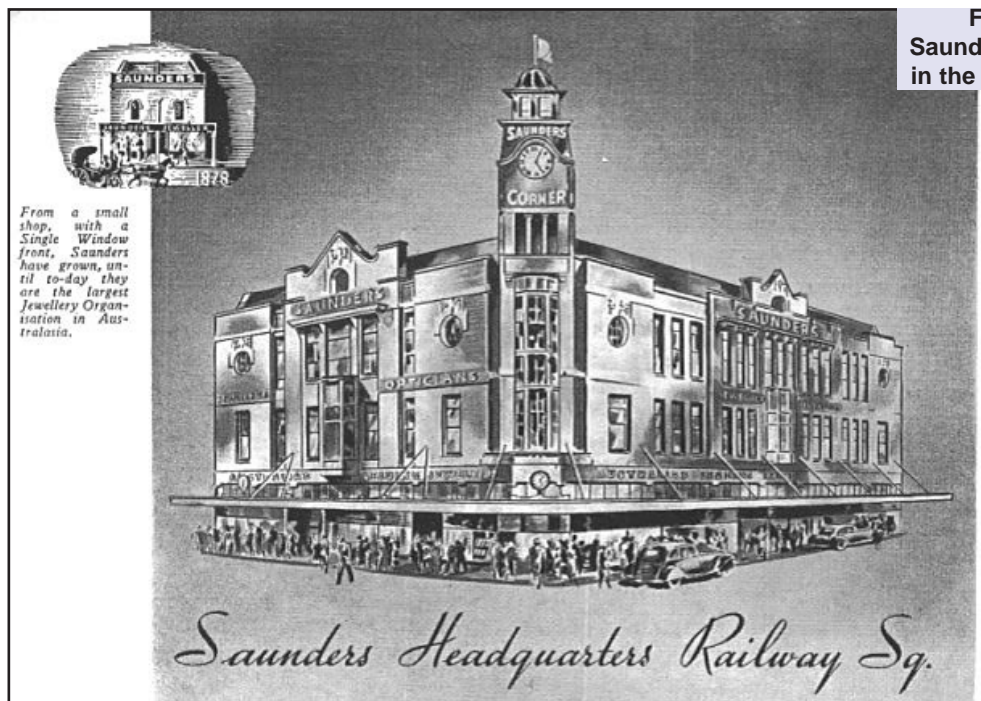
Figure 4. Saunders building in the early 1900s
